Hertfordshire County Council

Flood Investigation Report

Little Wymondley, Hertfordshire

07 November 2014 Rev 04
ERP-INV-04 Little Wymondley

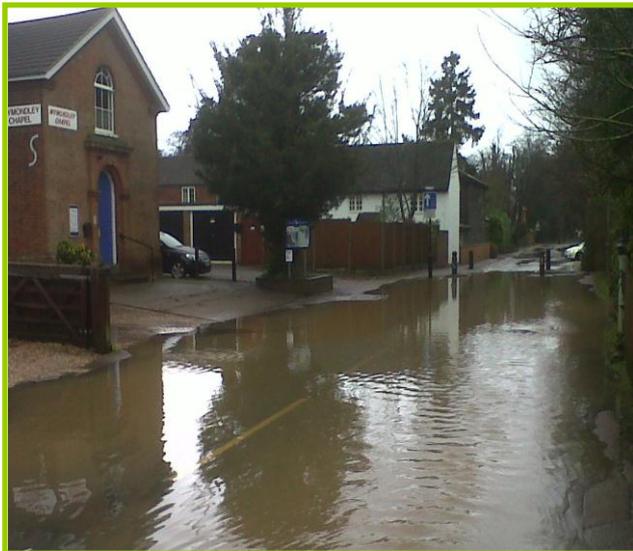
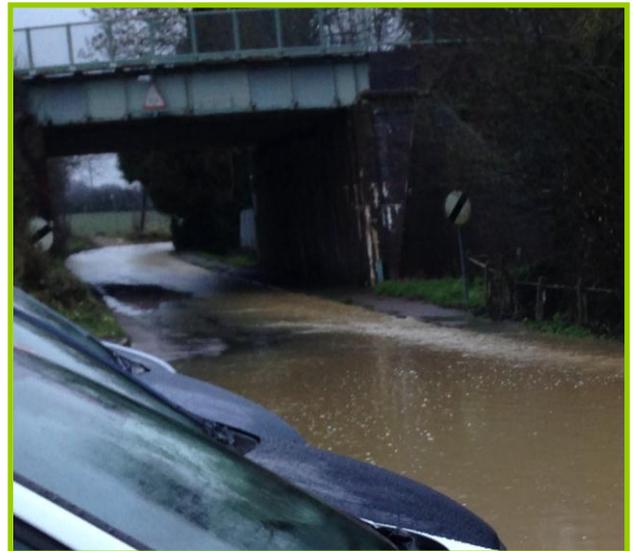
Photos provided by local residents of Little Wymondley

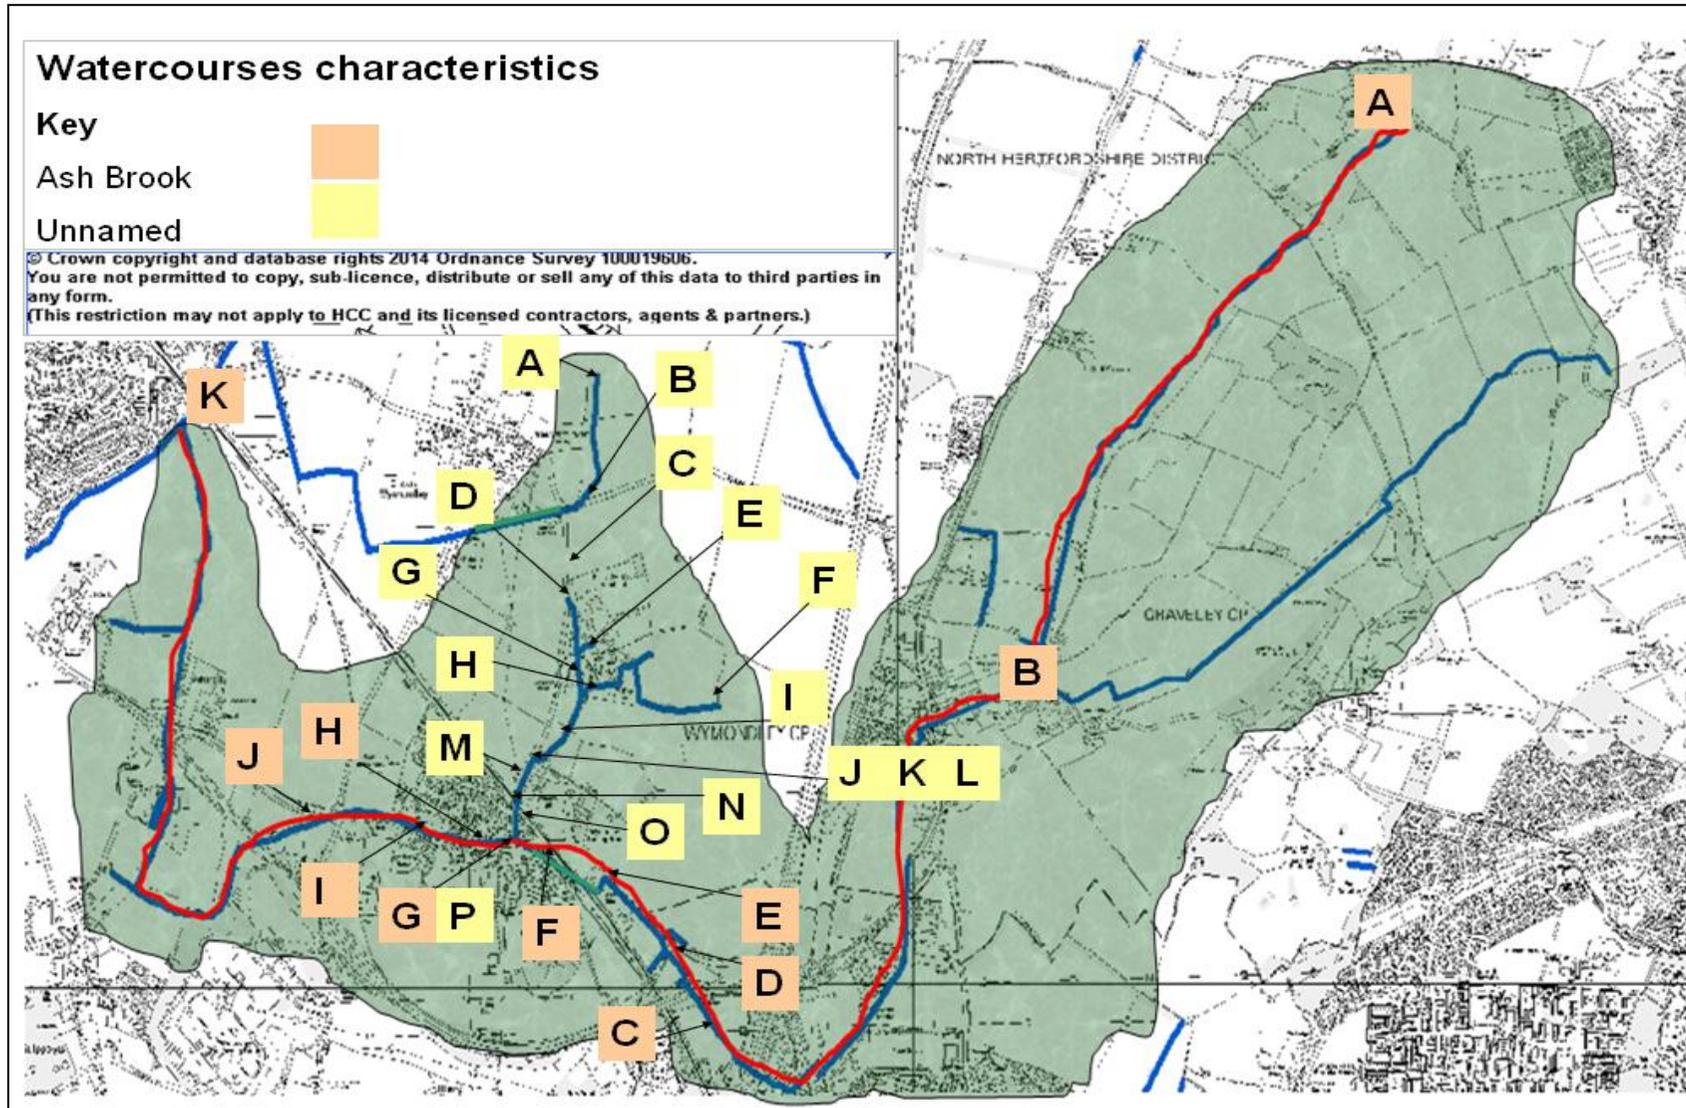
Figure 1.4.1

Little Wymondley lies within the lowest part of the catchment. The location and characteristics of the watercourses within the catchment are described in Tables 1.4.1 and 1.4.2 and can be viewed in Figure 2.

A	Starts near Green End north of Gravely
B	Flows through Gravely down to the A1 M then flows through Corey's Mill and under Junction 8
C	Flows from east to west through private farmland, reaches Chantry Lane where it enters a culvert with a smaller diameter with a vertical trash screen.
D	At the same point on the culvert there is another channel which discharges into it from underneath Stevenage Road. It appears to receive highway drainage and field drainage from the field to the north of Stevenage Road. Old maps show that there used to be a watercourse and an online pond within the field (see appendix 8b) - this is no longer present. There is an outfall from the field into the ditch which discharges into the culvert at Chantry Lane.
E	The Ash Brook continues to flow within a culvert of various diameters and construction along the southern boundary of Stevenage Road. There is a small open ditch flowing into the culvert adjacent to the allotments and car garage on Stevenage Road.

F	The Ash Brook remains in culvert and changes direction as it passes under the railway bridge and flows under the road to the northern boundary of Stevenage Road, until it reaches the corner of Priory Lane in Little Wymondley.
G	In this location the Ash Brook receives another watercourse where both are in open channel before passing under Priory Lane in a culvert. It is open again at the frontage of the Plume of Feathers Public House.
H	From here the watercourse is open with steep sides and varies in vegetation. There are numerous culverted crossings of the watercourse for vehicular access to residential properties. These vary in size and length. There are two large box culverts. One to access four residential properties and the other which forms Elms Close. Both of these culverts have large trash screens on the upstream side.
I	From Elms Close the watercourse is open in front of a commercial site then enters a lengthy culvert and becomes open again before Siccut Road.

M	It then flows into a culvert adjacent to a brick outbuilding and reappears outside the frontage of Wymondley House.
N	At this location there is an outfall which is believed to come from either a new culvert put in place due to collapse of an old culvert and a field drain which was found adjacent to the electrical substation on the west side of the road.
O	The channel reaches the railway line where it enters a brick arch culvert and opens again immediately on the south side of the bridge.

P	It is only open again for three to four meters then it enters another culvert before meeting the Ash Brook at the corner of Priory Lane and Stevenage Road.
---	---

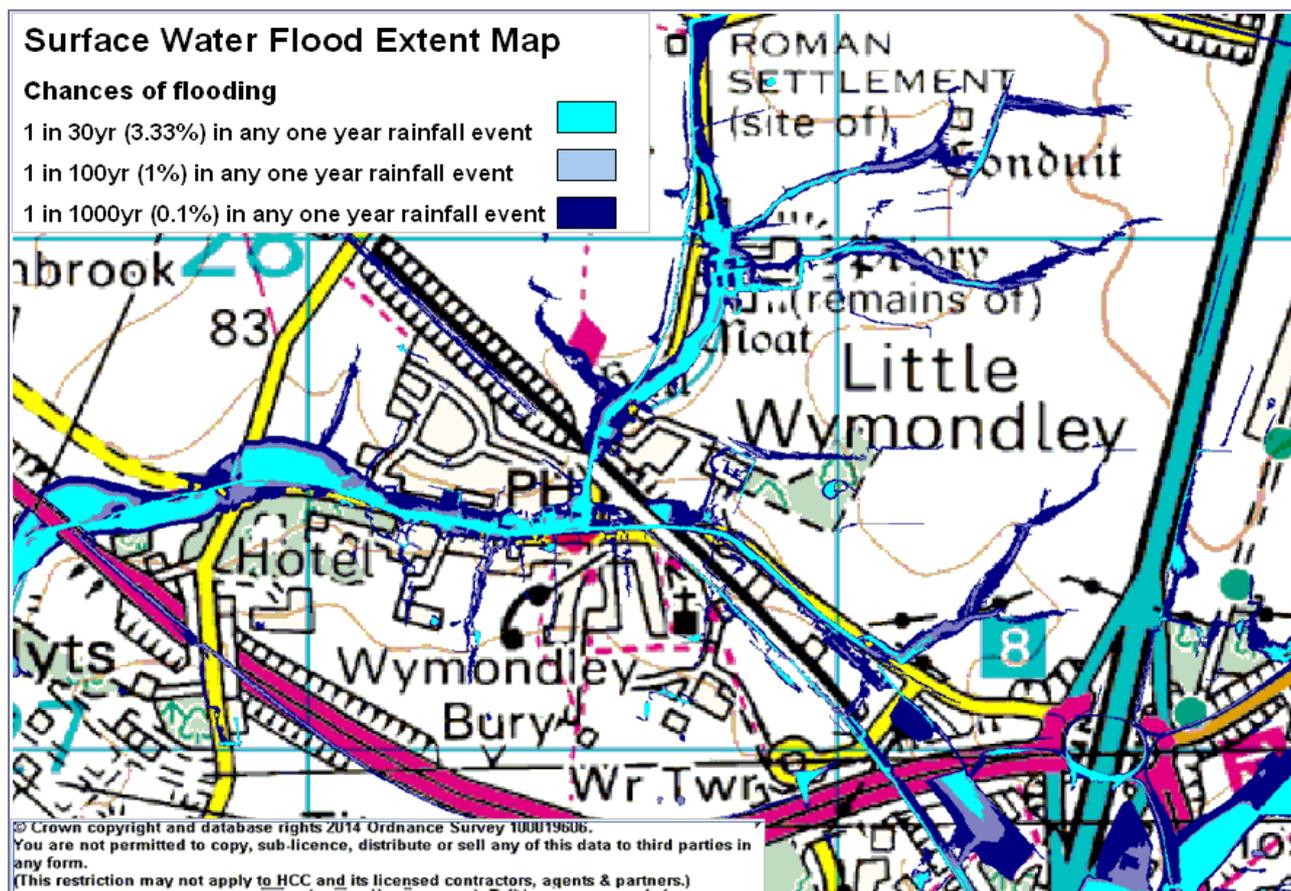
Figure 3.2.1

The risk of flooding from surface water map shows that Little Wymondley lies within a 'high risk' area susceptible to surface water flooding. The map below produced by HCC using the EA surface water data, represents the risk of surface water flooding using rainfall return periods.

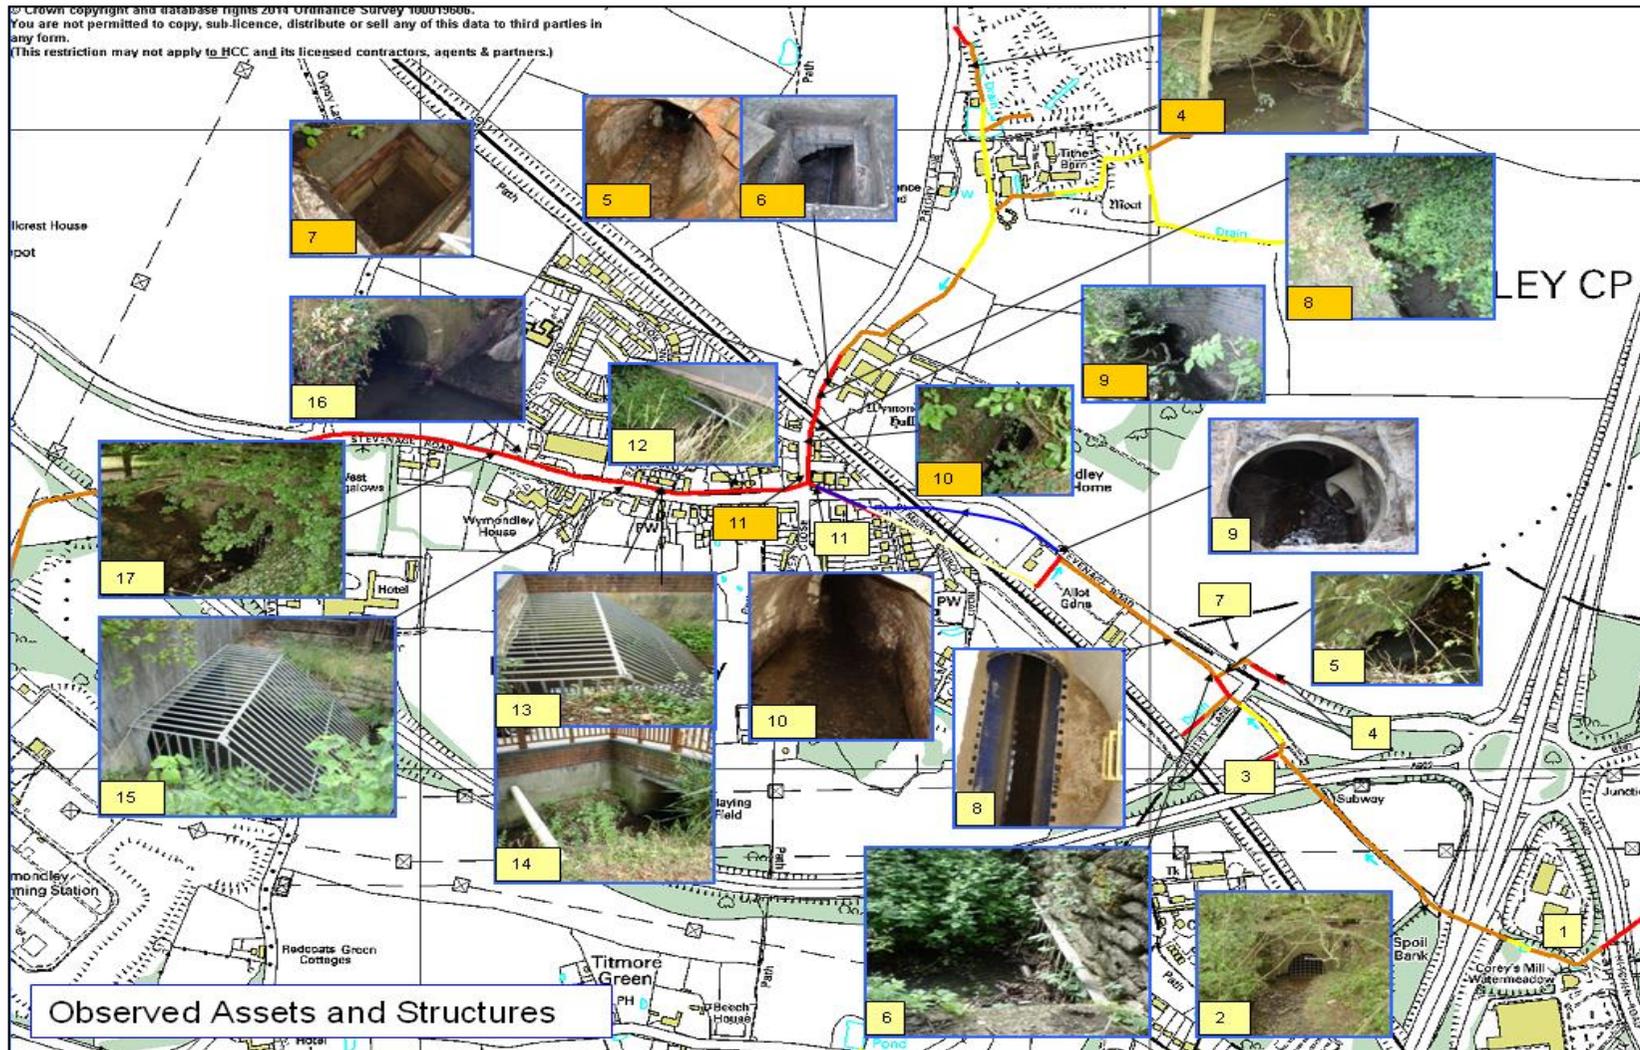
Figure 3.3.1

been installed within the culvert
6	Brick Arch culvert 450mm	Located in the centre of Priory Lane outside the frontage of Wymondley Hall Farm entrance. Appears to have been broken into the top with a couple of lose bricks within the culvert.
7	Field drainage outlet	Located within the adjacent field next to the north west side of the railway bridge on Priory Lane. Heavily silted and could not see outlet from manhole.
8	450mm downstream culvert outlet frontage of Wymondley Hall farm	Located upstream of the railway bridge adjacent to Priory Lane within the west side verge.
9	Downstream outlet brick arch culvert	Located underneath the railway bridge west of Priory Lane.
10	Upstream inlet culvert 600mm	Located downstream of railway bridge on Priory Lane underneath verge west of Priory Lane.
11	Downstream outlet culvert 600mm	Located at the junction of Priory Lane and Stevenage Road

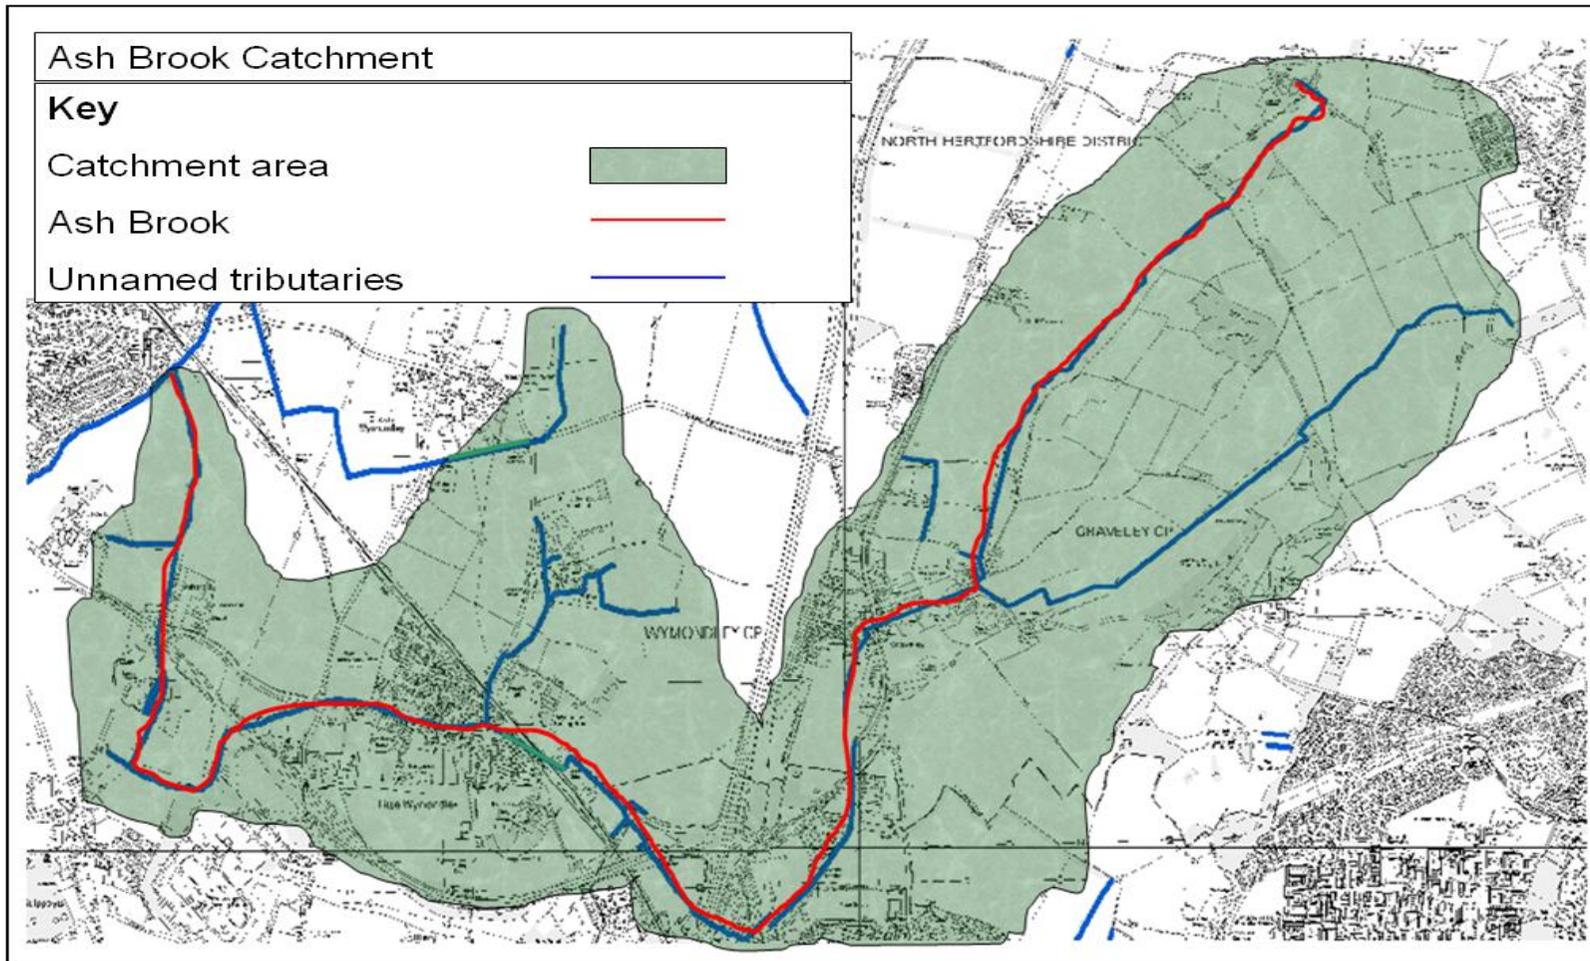
Appendix 1- Ash Brook Catchment

Little Wymondley lies within the catchment of the Ash Brook. Based on the information on the OS Maps and topography, the source of the Ash Brook is identified as being within Grove Wood near Green End north of the village of Graveley. See Appendix 1

It then flows through Graveley and is joined by another watercourse flowing from the east of Graveley. Once it has left Graveley it flows underneath the Stevenage bypass and into an online attenuation pond known as Corey's Mill water meadow.

The Ash Brook then continues into Little Wymondley where it is joined by another watercourse from the north which runs alongside Priory Lane. The Ash Brook continues west along Stevenage Road and eventually flows into the Ippollitts Brook at Hitchin.

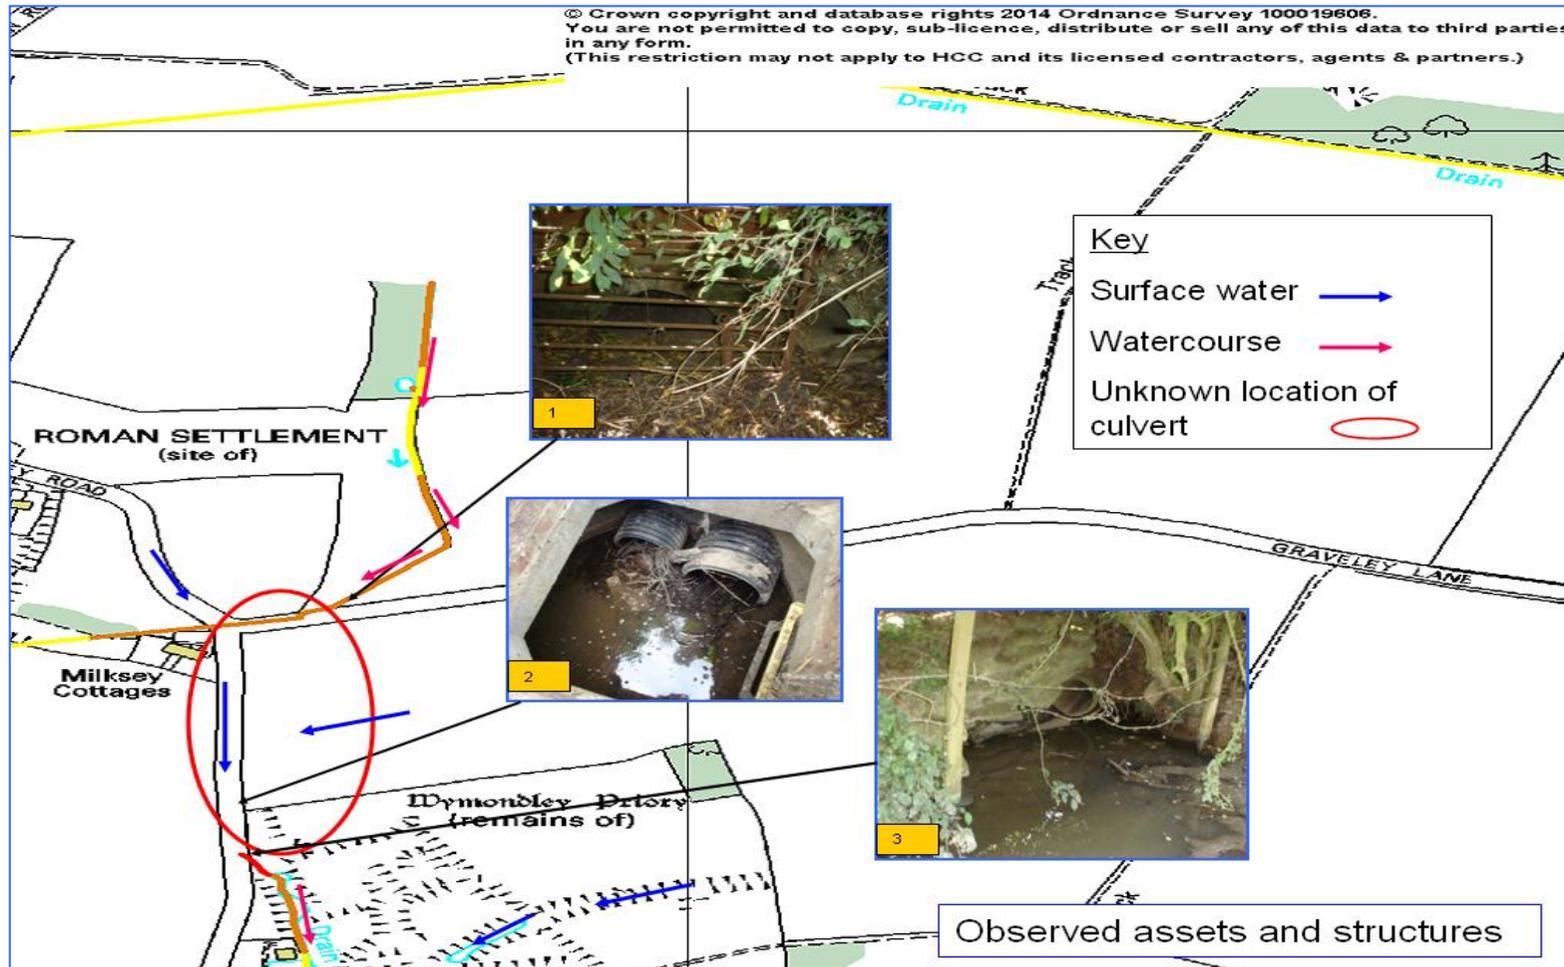
Appendix 3b Observation of flood flows

All of the observations below have been recorded on diagrams in appendix 3a and 3b showing the location and direction of water flowing from the surrounding land and watercourses. Appendix 4 provides photos of the flooding that occurred on the 7 February 2014 obtained from HCC Highways and local residents.

It was then observed by residents that water was flowing down Priory Lane onto Stevenage Road which joined water flowing from the east along Stevenage Road. The rising flood water resulted in the roads becoming impassable.

As water flowed into Little Wymondley, the flood water was added to by flows down Priory Lane. It was observed by staff at the Priory, water was flowing from an adjacent field to the entrance of the Priory onto Priory Lane.

Wymondley Hall Farm observed surface water run-off flowing from the east of the rear of the farm which then flowed through the farm yard onto Priory Lane via the farm entrance.
